## Evaluation of glulam beams after 6 years exposure to outdoor climate

*Project leader:* Birte Pitzner, Arne Rambøl and Per Lind,  
Norsk Treteknisk Institutt  
*Date:* 2004-09-01  
*Project no.:* FP-43/03, FP-58/03, FP-59/03 (TEFT)

The aim of this project is to evaluate the condition of glulam beams after they have been exposed to outdoor climate for six years. They were installed with a 45° angle facing south, on the roof of Moelven Limtre Agder in southern Norway in 1997.

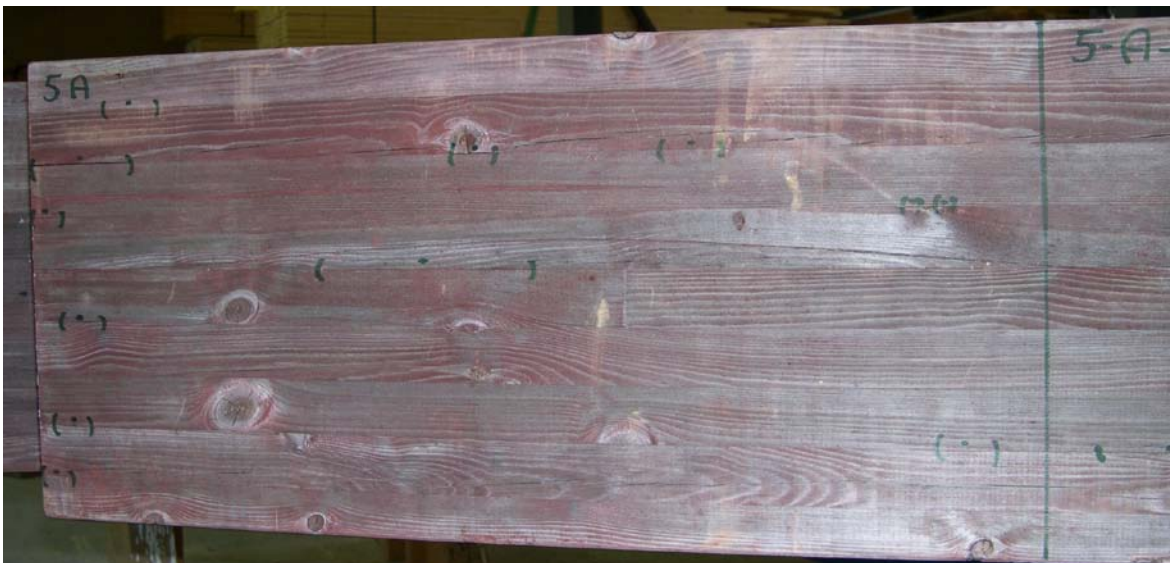
Figure 4.2 Glue line openings – Beam 5A (12,6 %)

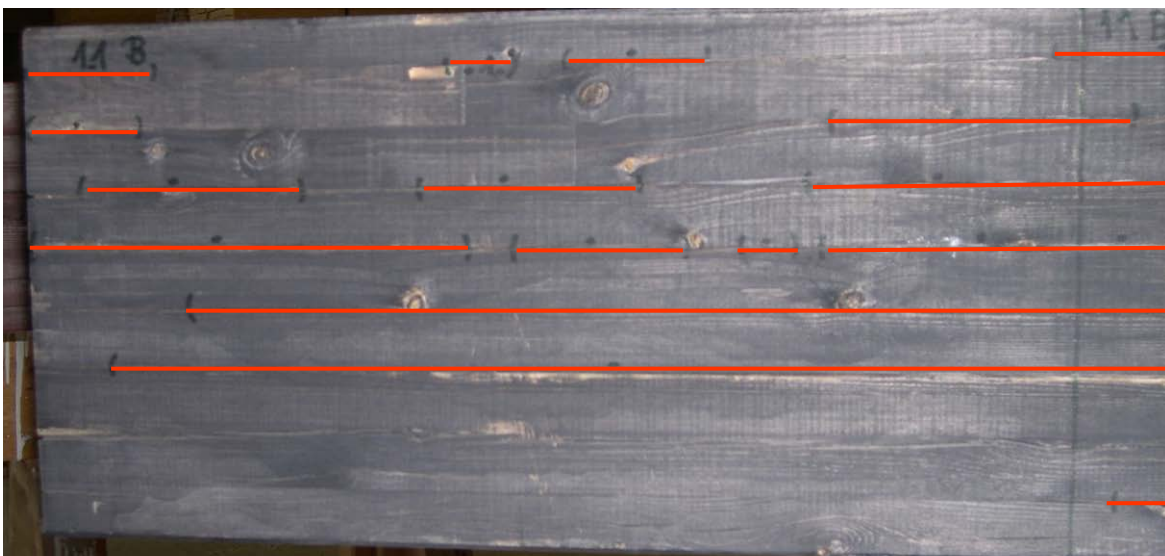
Another interesting result is shown in the last two columns. Beams 10 and 11 were both impregnated with CCA, like beams 4 and 5, but not treated with the full Royal process. Beam 10 was left without any surface treatment and beam 11 was stained with a grey-black oil-based stain. Between these two treatments it became obvious that the dark surface treatment had a negative influence on the glue lines. The comparison of all the beams impregnated with CCA shows that the best results concerning the glue line openings on the long side were reached by the beams which were also treated with the full Royal process (beams 4 and 5).

Figure 4.3 Glue line openings – Beam 11B (53 %)

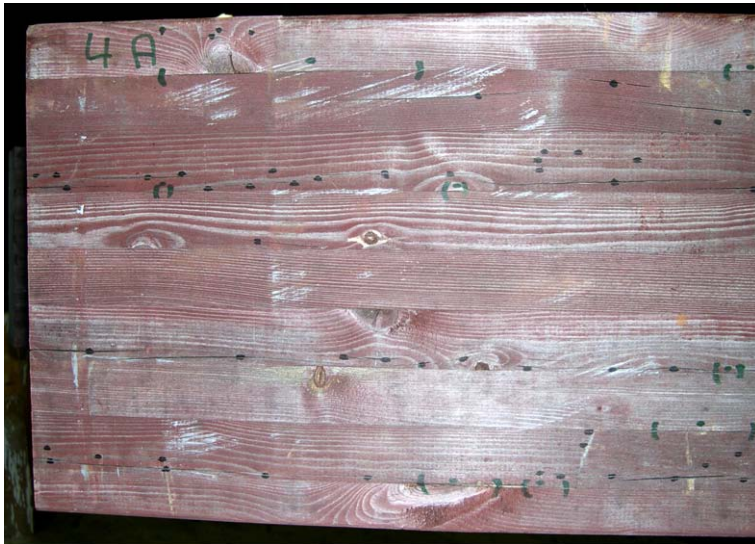
The three beams impregnated with CCA (4A, 10B and 11A) show noticeable differences to the others. These three beams make it obvious that the surface treatment has a great influence on the development of glue line openings and cracks in the wood. Beam 4A (Full Royal process) developed less glue line openings than all the other beams but on the other hand the amount of cracks was on the same level as the others were, except for beam 10B. Beam 10B (no further treatment after the impregnation with CCA) also had less glue line openings, but the highest amount of cracks in the wood. The last of the CCA-beams (11A) was treated with a dark grey-black oil-based stain and showed the highest amount of glue line openings of all the beams. On the other hand the wood crack amount was on the same level as the majority of the beams.

*Figure 4.6 Beam 4A. Glue line openings and cracks*

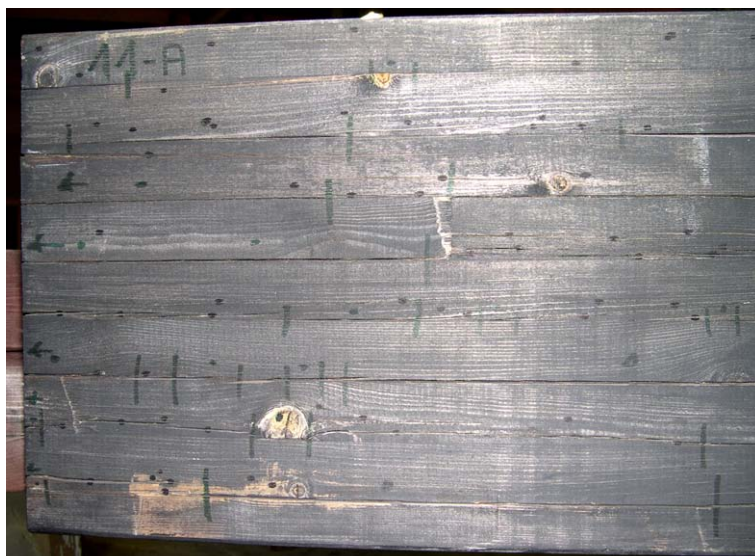
*Figure 4.7 Beam 11A. Glue line openings and cracks*
