## Evaluation of glulam beams after 6 years exposure to outdoor climate

*Project leader:* Birte Pitzner, Arne Rambøl and Per Lind,  
Norsk Treteknisk Institutt  
*Date:* 2004-09-01  
*Project no.:* FP-43/03, FP-58/03, FP-59/03 (TEFT)

The aim of this project is to evaluate the condition of glulam beams after they have been exposed to outdoor climate for six years. They were installed with a 45° angle facing south, on the roof of Moelven Limtre Agder in southern Norway in 1997.

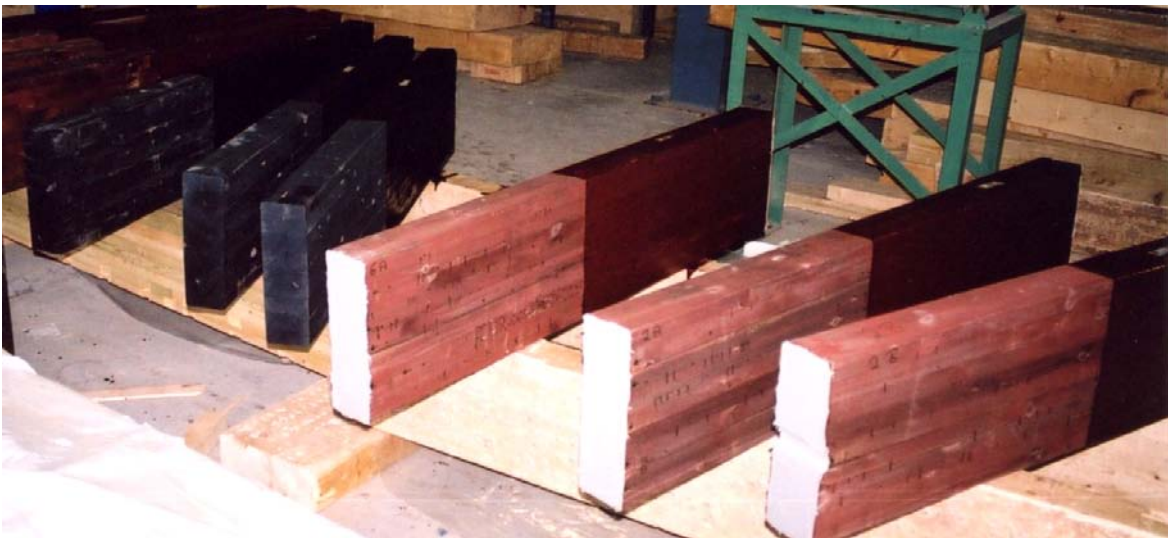
*Figure 2.5 Surface treatment of the right beam sections with two different stains*

The right side of the remaining shorter beams received a fresh surface treatment, except for beams 10A and B. The beam sections were painted with two layers of oil-based stain in different colors:

1. Butinox I, 527 Antikkbrun
2. Butinox I, 561 Blodbøk

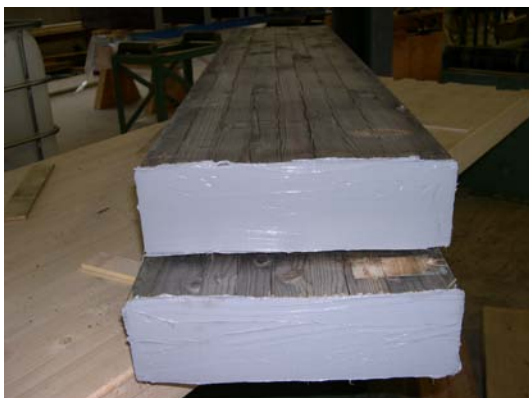
*Figure 2.6 Sealed cross cut ends, beams 10A + 10B*

The cross cut ends were sealed with silicone. The 22 now shorter beams were lifted back up on the roof to be tested again on a later occasion.

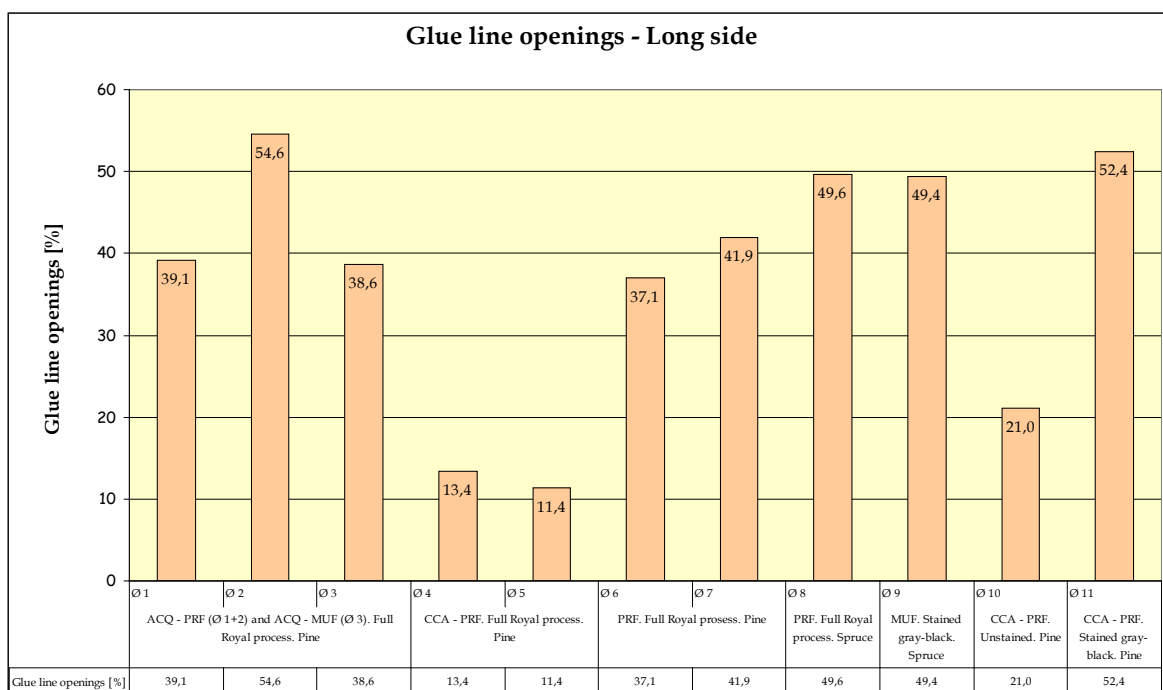
Figure 4.1 Results - Glue line openings – Long side

The opening percentages were calculated in relation to the total length of the glue lines. Beam A and B were placed together in average values ( $\emptyset$ ). The percentage values of the glue line openings vary between 11,4 % and 54,6 %. The beams 4 and 5 had the lowest amount of openings. The lamellae were impregnated with CCA before the beams were treated with the full Royal Process. The percentages differ only between 11,4 % and 13,4 %. The beams manufactured of ACQ-impregnated lamellae, which were afterwards treated with the full Royal Process (beams 1, 2 and 3), and the beams manufactured of untreated lamellae but treated with the full Royal Process (beams 6 and 7) did not show great differences in the amount of the openings, but the percentages were definitely higher than those of the beams manufactured of CCA- impregnated lamellae.

Another interesting result is shown in the last two columns. Beams 10 and 11 were both impregnated with CCA, like beams 4 and 5, but not treated with the full Royal process. Beam 10 was left without any surface treatment and beam 11 was stained with a grey-black oil-based stain. Between these two treatments it became obvious that the dark surface treatment had a negative influence on the glue lines. The comparison of all the beams impregnated with CCA shows that the best results concerning the glue line openings on the long side were reached by the beams which were also treated with the full Royal process (beams 4 and 5).

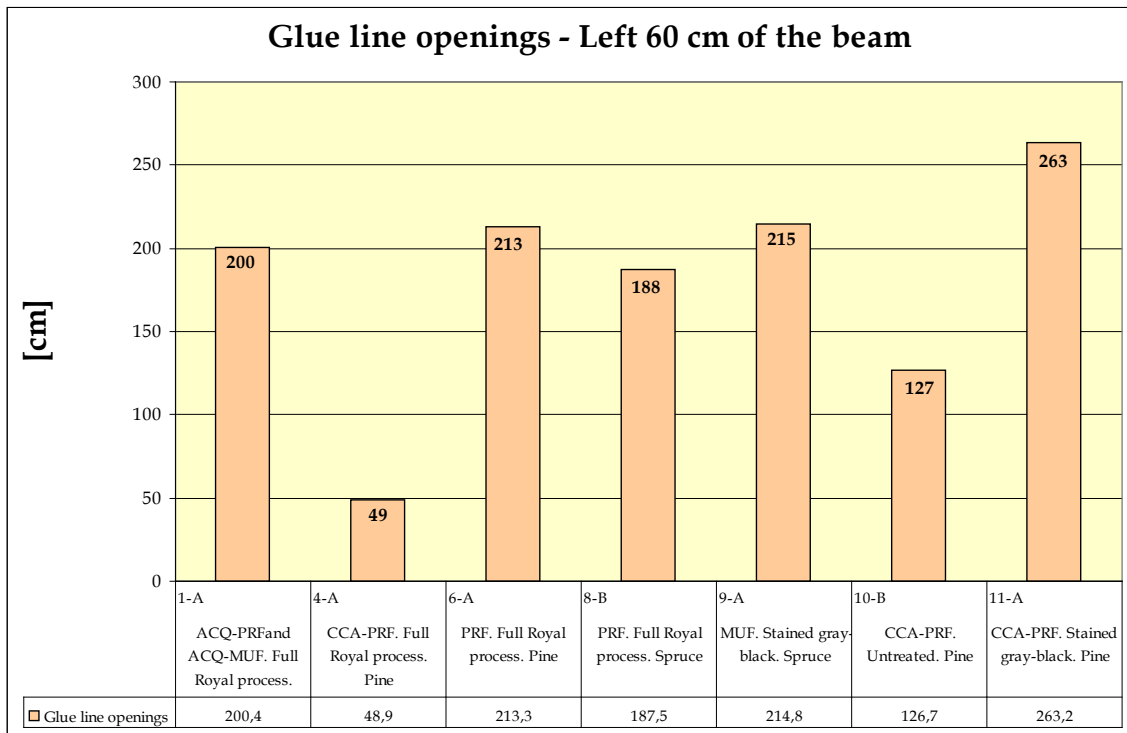
Figure 4.4 Glue line openings - Left 60 cm of the beam

The two figures (figure 4.4 and 4.5) show the relation between the openings in the glue lines on the long side of the beams and the occurrence of cracks in the wood. One beam was selected from each group and the openings in the left 60 cm were measured and recorded.

The three beams impregnated with CCA (4A, 10B and 11A) show noticeable differences to the others. These three beams make it obvious that the surface treatment has a great influence on the development of glue line openings and cracks in the wood. Beam 4A (Full Royal process) developed less glue line openings than all the other beams but on the other hand the amount of cracks was on the same level as the others were, except for beam 10B. Beam 10B (no further treatment after the impregnation with CCA) also had less glue line openings, but the highest amount of cracks in the wood. The last of the CCA-beams (11A) was treated with a dark grey-black oil-based stain and showed the highest amount of glue line openings of all the beams. On the other hand the wood crack amount was on the same level as the majority of the beams.

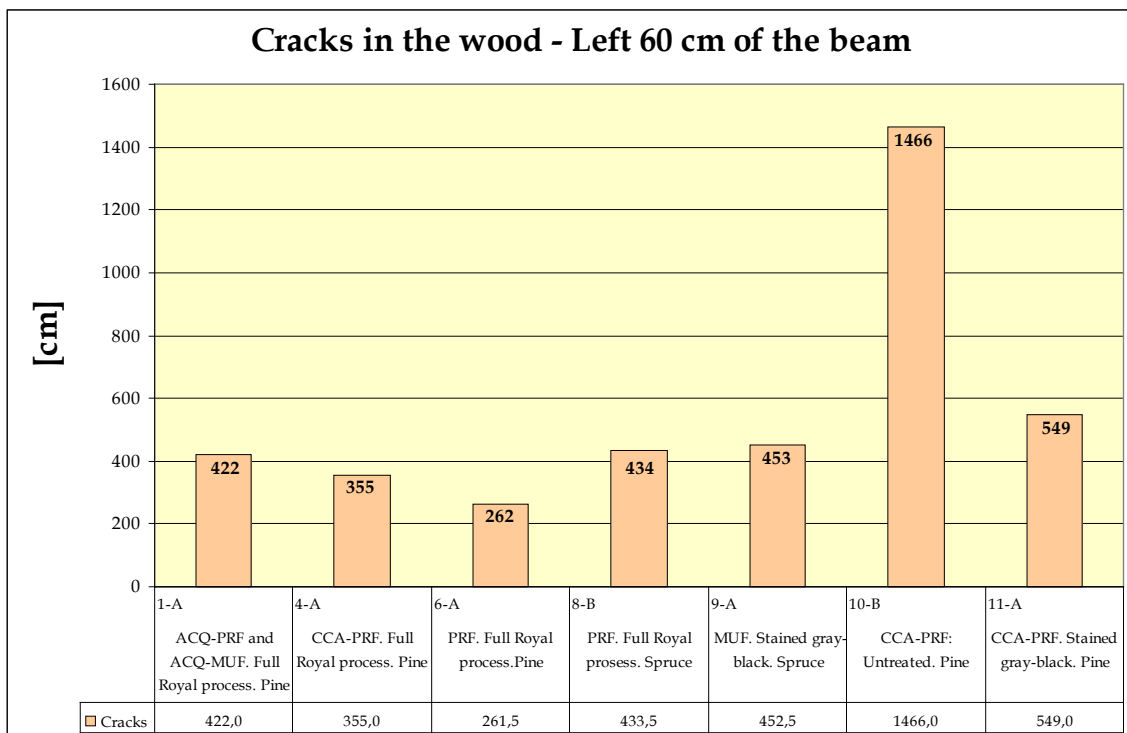
Figure 4.5 Cracks in the wood - Left 60 cm of the beam

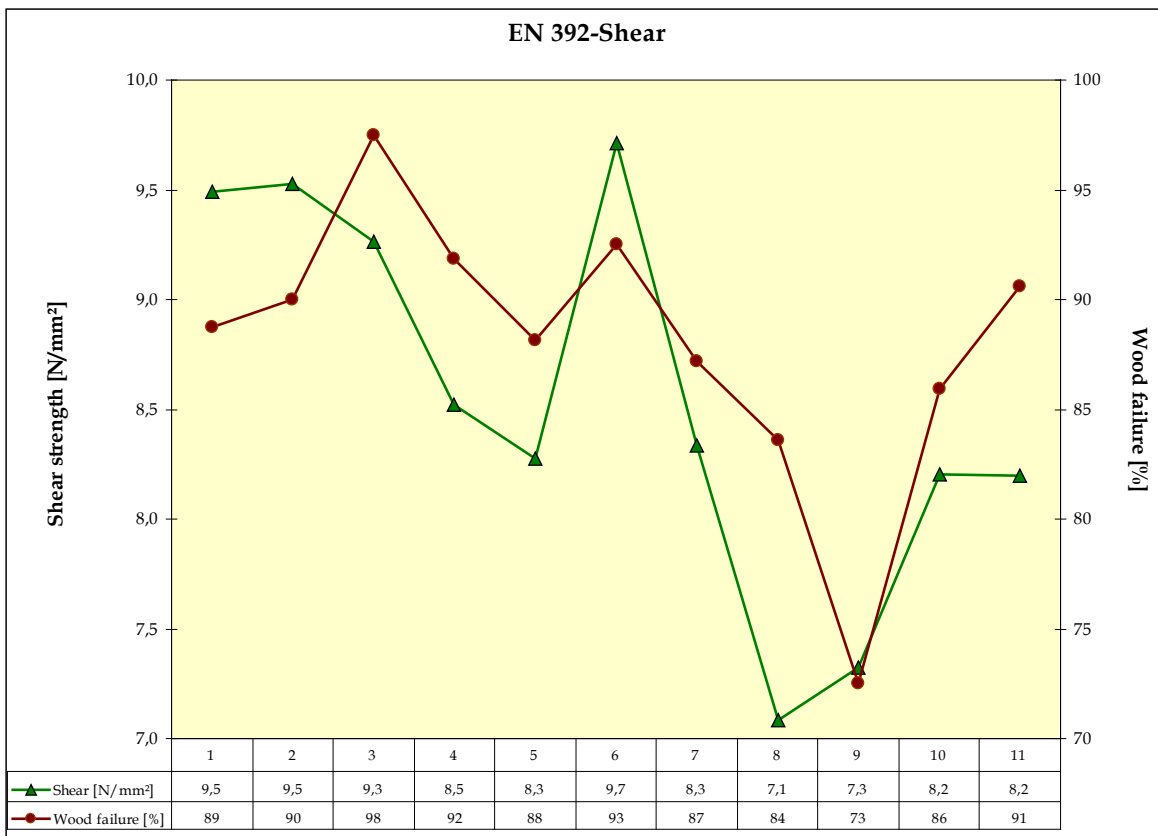
Figure 4.11 Relation between shear strength and wood failure percentage

This figure (figure 4.11) shows the relation between the shear strength results (green line) and the wood failure percentages (red-brown line) with another scale as the previous figures. A similar pattern between the two lines is recognizable.

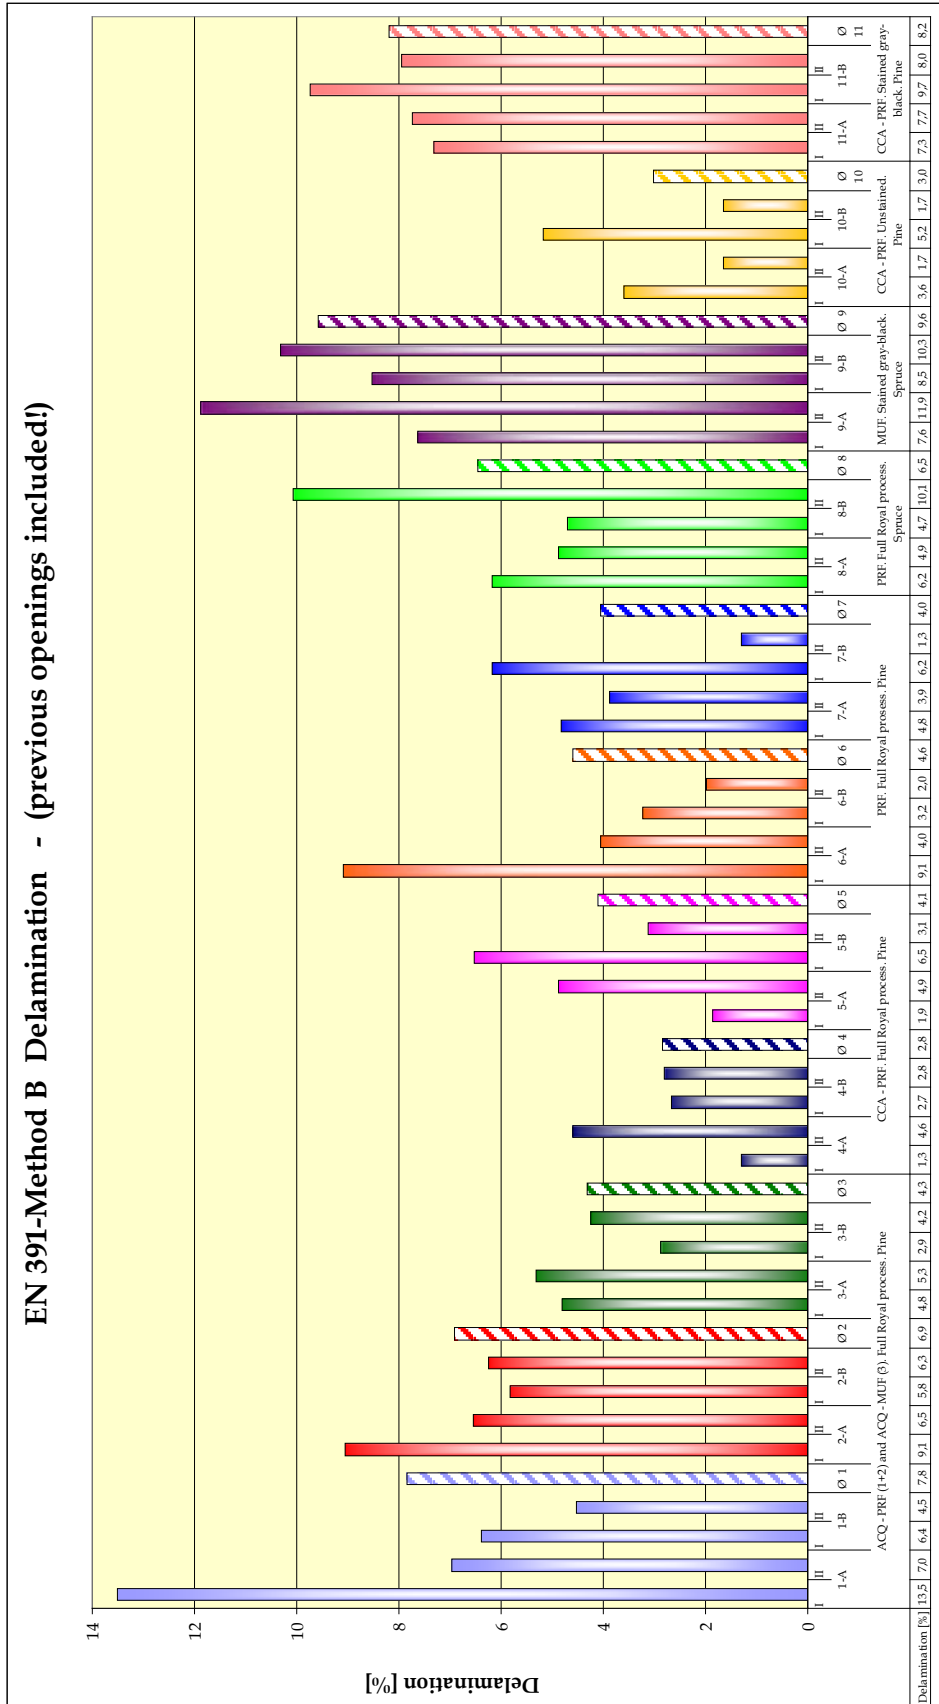
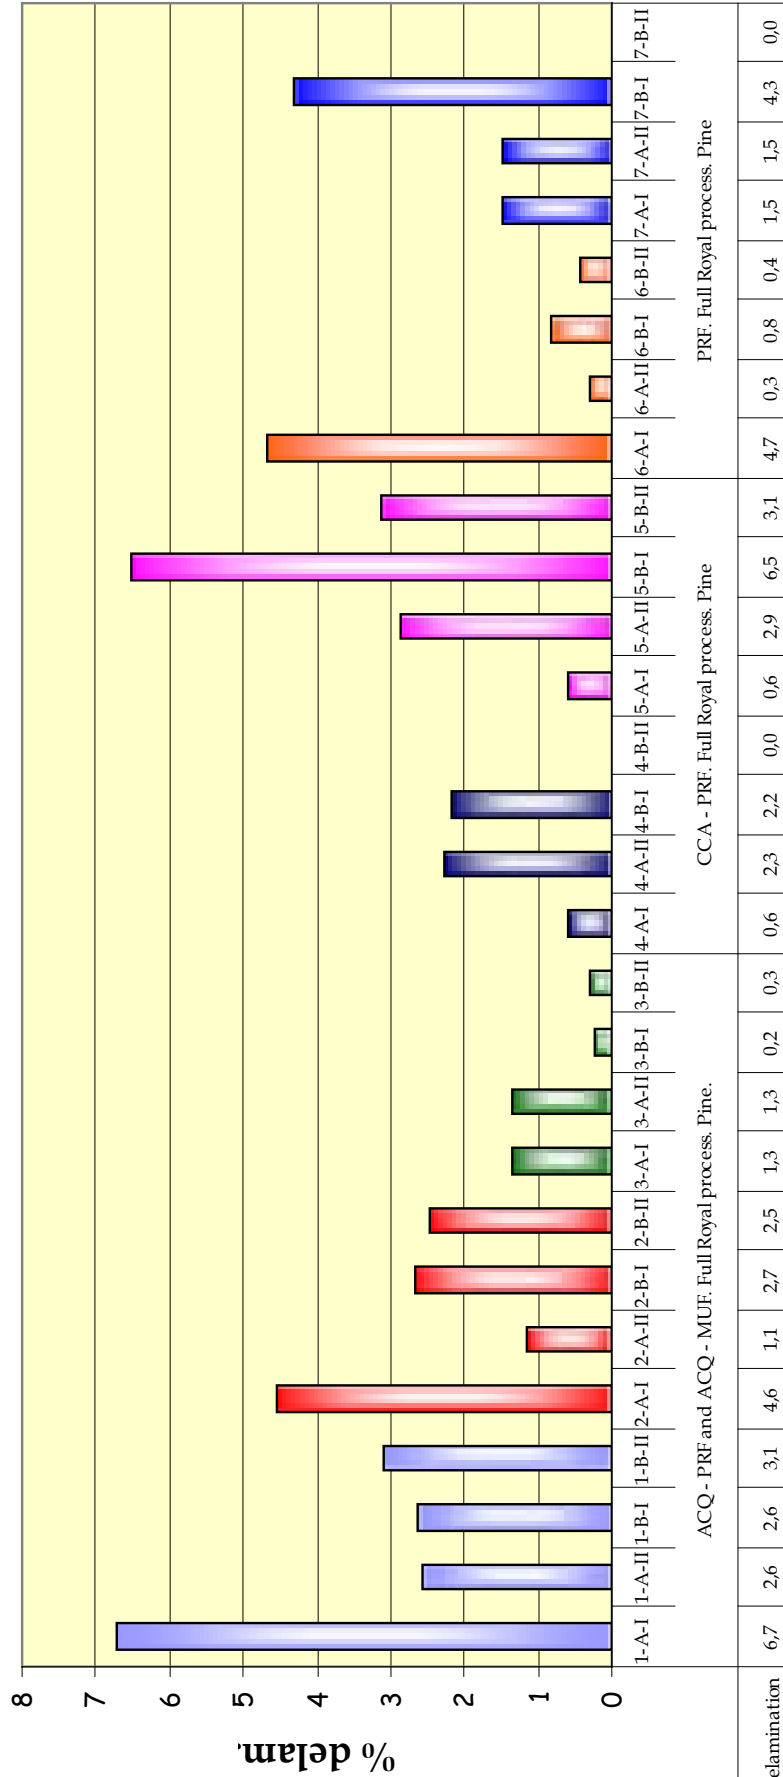
The second diagram in the appendix (figure A-2.2) only shows the delamination percentages that were caused by the delamination test EN 391, method B. Only one test cycle has been carried out.

*Figure A-2.2 (see p. 26+27): EN 391-B - Delamination percentages*

# Delamination according to EN-391 - method B. New openings only.

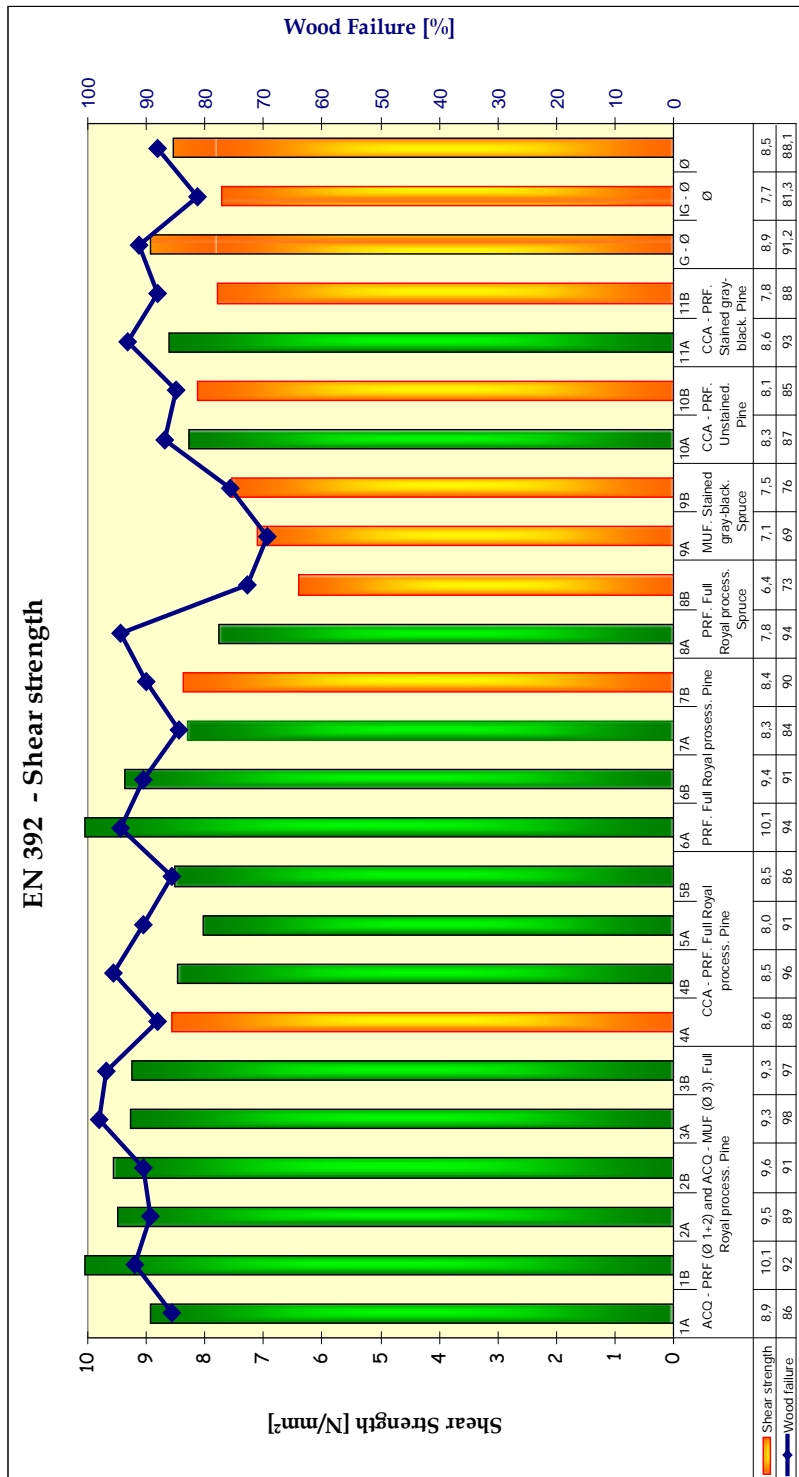
Figure A-3.1 Shear test EN 392. Single results of the beams

The green columns stand for accepted test results, whereas the orange columns stand for the beams which did not pass the test. The blue line on top of the columns represents the wood breakage percentages.
